Precision Bathymetric Survey for Marine Infrastructure: A Case Study of Bullnose Jetty, Lagos, Nigeria

Abstract: A precision bathymetric survey was conducted at Bullnose Jetty, Apapa, Lagos, ahead of piling and repair activities. The survey employed a single-beam echo-sounder coupled with GNSS positioning and produced high-resolution 0.1 m grid data. Depths across the study area ranged from 10.1 m to 13.2 m relative to the measured surface elevation. Probing at proposed pile points (A-38_new, A-39_new, A-40_new) found no obstructive debris, and the broken pile (P39A) was located and mapped, lying flat on the seabed. These results informed safe pile placement and confirmed the suitability of the repaired pile positions. The study provides one of the first high-resolution bathymetric validations focused on damaged-pile assessment at Bullnose Jetty, Lagos, filling a local demand for precision in-situ seabed evaluation for maintenance and repair planning. Practical implications include improved pile-driving planning, reduced risk of pile collision with submerged debris, and enhanced operational safety during repair works.

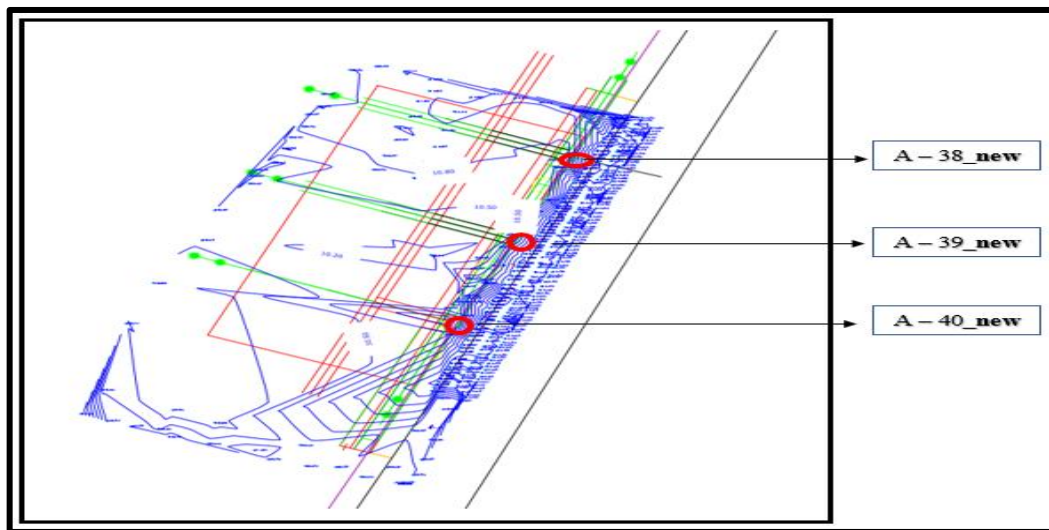
Figure 4. Overlay of 2D plot and bathymetric chart lines within observed area

The seabed across the surveyed area exhibited an undulating bathymetry with corrected depths ranging from 10.1 m to 13.2 m relative to local datum. Measurement uncertainty was quantified by calculating the standard deviation of repeated soundings on control transects and by combining instrumental vertical error (VPE $\approx \pm 0.03-0.08$ m) with the uncertainty from tidal corrections (estimated ± 0.05 m from tide logger variability). The combined expanded uncertainty

($k=2$) for corrected depths is estimated at approximately ± 0.20 m, which is sufficient for engineering decisions on pile placement and obstruction avoidance. Figure 4 illustrates the overlay of bathy lines on the 2D plot of the sounding area, while Figure 5 shows the topographic profile. These results provided critical data for engineering designs while ensuring that seabed depths align with the operational requirements of the jetty. Variations in seabed depth can influence pile design and the overall stability of structures. These variations may be attributed to hydrodynamic forces such as tidal

currents and vessel-induced turbulence, particularly near the quay edge. Such forces can cause sediment redistribution and scouring that affect structural integrity over time. Identifying deeper or irregular sections informs the strategic placement of piles to enhance structural integrity. When compared with similar surveys at the Benin River [3] and Badagry Creek [16], the Bullnose Jetty area exhibited more pronounced seabed variability. This may be due to heavier vessel traffic and structural influences on local sediment transport.

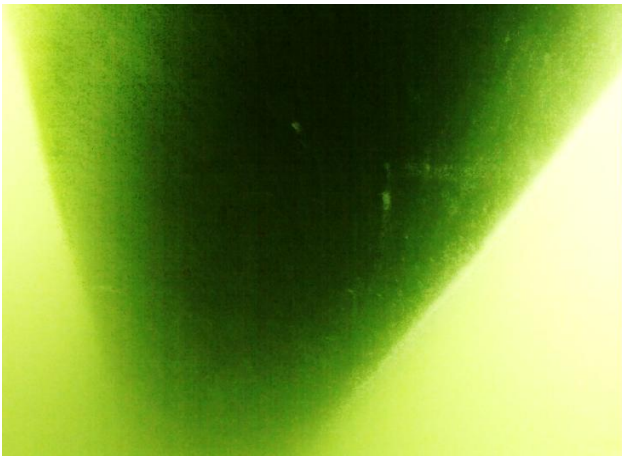
Plate 4: P38_new

The newly installed piles were inspected using underwater videography and bathymetric probing. No subsurface obstructions were detected beneath the new piles within the survey uncertainty envelope. These findings corroborate with prior pre-installation surveys in similar Lagos port settings carried out by [26], which reported comparable depth variability and the importance of high-resolution sounding for pile planning. The newly installed piles (P38_new, P39_new,

P40_new) were observed to be vertically aligned and firmly driven into the seabed. Underwater video footage confirmed that there were no obstructions beneath these piles, affirming their stability and suitability. The absence of obstructions beneath newly installed piles also reflects the effectiveness of sediment clearance in zones prone to dynamic sedimentation. This confirms that proper pre-installation bathymetric probing mitigates risks of misalignment due to sediment buildup. Find attached photographs of the piles.

As shown, it is clear that all the newly installed piles are firmly and truly vertical. As can be further confirmed from the videos, none of the newly installed piles is slanted. Furthermore, by checking them to the base, we observed that all the piles were driven through the earth, firmly into the seabed. Therefore, we conclude that the newly installed piles do not show any signs of obstruction

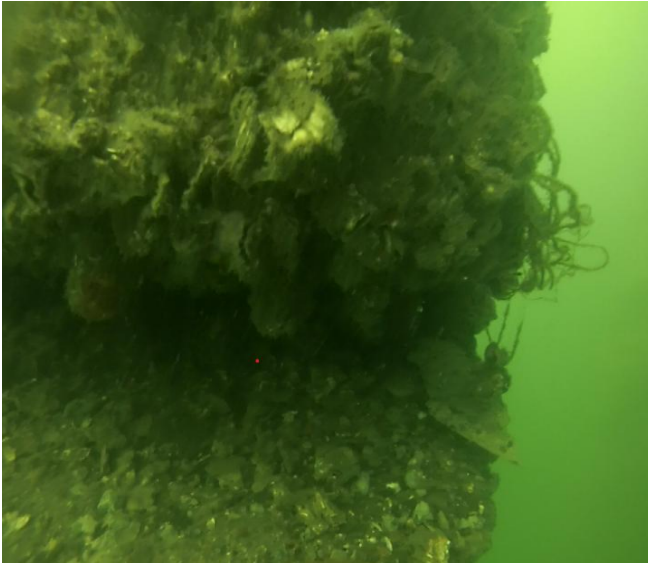
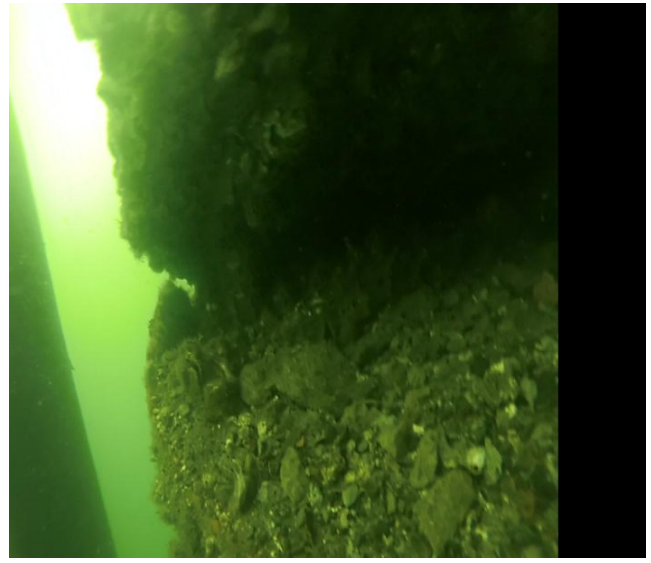
Visual evidence and bathymetric mapping show that pile P39A is broken and lying flat on the seabed in front of P38A. The fracture morphology and location suggest a sudden impact or overload event, consistent with collision or a concentrated lateral load followed by structural failure [17].

Localized seabed resistance around P38A noted during probing may have contributed to asymmetric loading during the incident. While a definitive mechanical failure analysis is beyond the scope of this survey, these observations recommend further structural assessment, such as material testing and finite-element analysis, if needed.

Plate 7. P38A: Broken in the middle by the impact of the accident

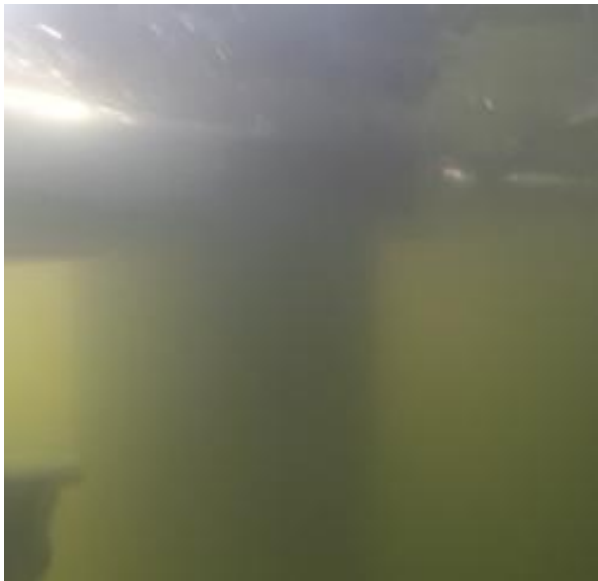
Plate 9. P38 B

Surrounding piles, including P38B, P38C, P39B, P39C, P40B, and P40C, were visually examined and found to be unaffected by the impacts. These piles maintained their structural integrity and vertical alignment, as confirmed by both photographic and physical inspections. This finding supports the localized nature of the damage and further reduces the concerns about potential widespread structural issues.

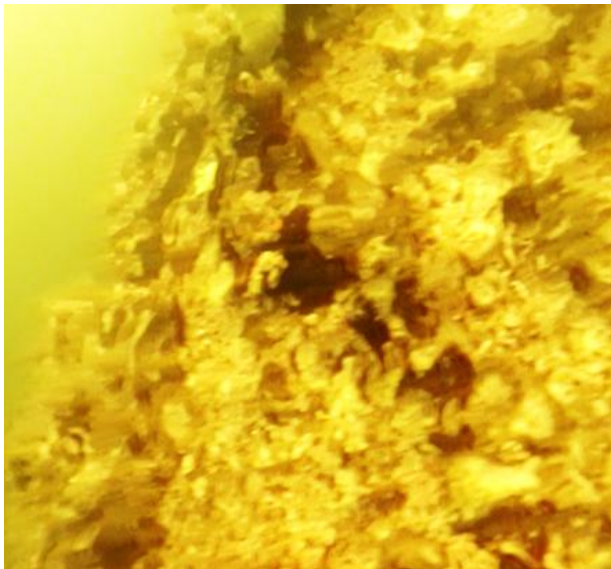
Plate 15. P50A

Further examination was extended to piles outside the immediate repair area, specifically P50A and P58B. These piles were confirmed to align with the original design specifications, maintaining consistency with the newly installed piles. Photographs of P50A and P58B corroborate these observations, reinforcing the overall structural coherence of the jetty.

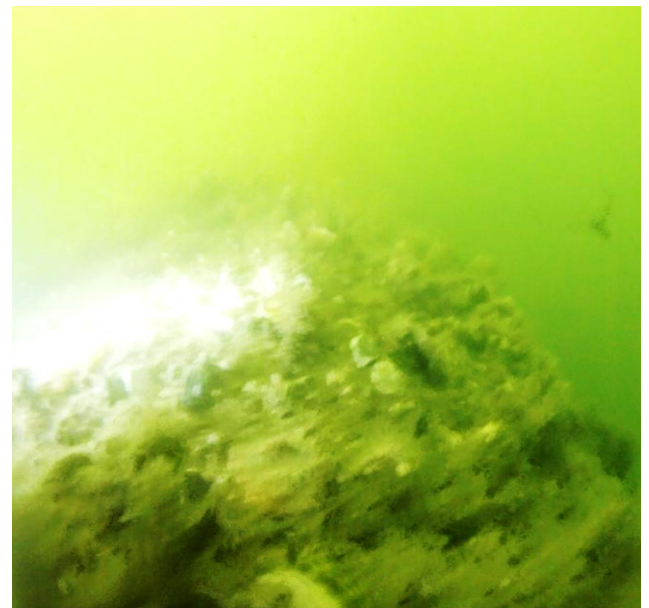
Plate 17. P39A

The investigation also identified the location of the broken pile (P39A), which was found lying flat on the seabed in front of P38A. Its position dispels concerns regarding potential subsurface obstructions that might interfere with the new pile installation or vessel berthing operations. This discovery provides additional assurance about the safety and feasibility of ongoing repair activities.
